# The Play Inspection Co.

## Congas

Staple Ash Ln, Froxfield,  
Petersfield GU32 1DJ

Assessment Date: 10th February 2023  
Assessor: Keith Dalton  
Manufacturer: Percussion Play Ltd  
Risk Assessment: Very Low Risk

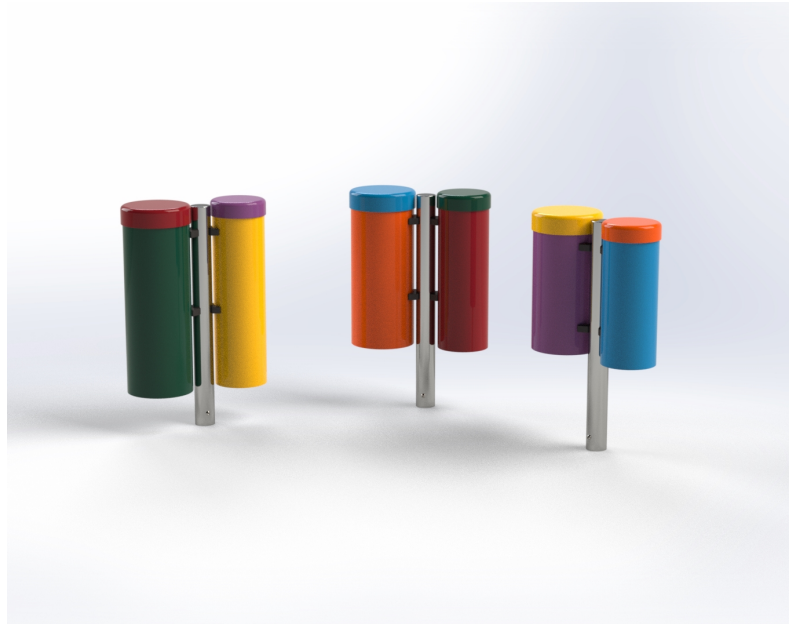
With all control measures applied there will still be a risk remaining of users colliding with the equipment or with other users. It is considered that this remaining risk is of no significance, or any different from similar equipment item that incorporates this type of movement.

Given the provision of the safety measures detailed the remaining risk is considered to be 1 x 2 VERY LOW RISK

**Additional Controls Required:**           None
