Sansa Rimba

Staple Ash Ln, Froxfield,
Petersfield GU32 1DJ

Assessment Date: 30th September 2021

Risk Assessment: Very Low Risk

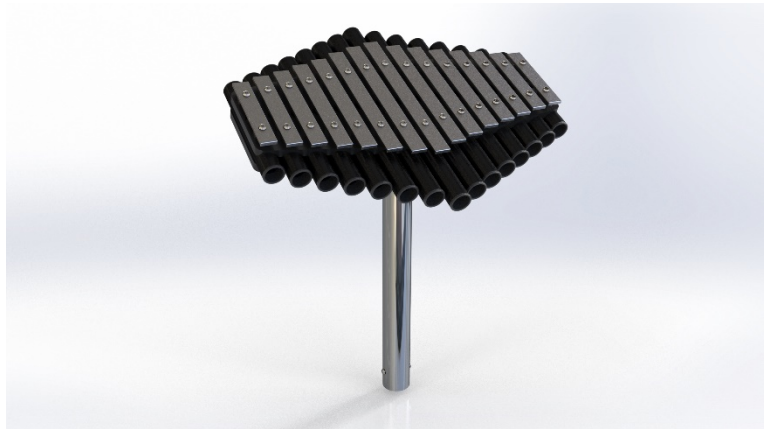
- Collision

With all control measures applied there will still be a risk remaining of users colliding with the equipment or with other users. It is considered that this remaining risk is of no significance, or any different from similar equipment item that incorporates this type of movement.

Given the provision of the safety measures detailed the remaining risk is considered to be 1 x 2 VERY LOW RISK

Additional Controls Required: None
