# The Play Inspection Co.

## Cavatina

Assessment Date: 27th September 2021  
Assessor: Keith Dalton  
Manufacturer: Percussion Play Ltd  
Risk Assessment: Very Low Risk

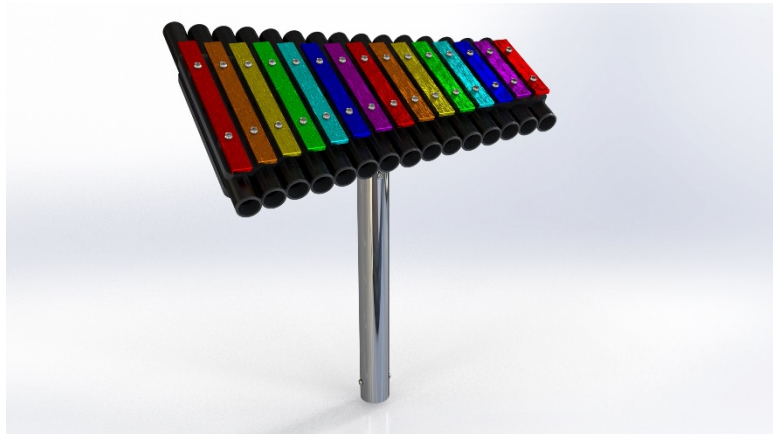
- Collision

With all control measures applied there will still be a risk remaining of users colliding with the equipment or with other users. It is considered that this remaining risk is of no significance, or any different from similar equipment item that incorporates this type of movement.

Given the provision of the safety measures detailed the remaining risk is considered to be 1 x 2 VERY LOW RISK

**Additional Controls Required:**        None
